# Drone in sediment management: Grono power plant case study

Practical application

Bologna Hydro 2026, Mehmet Fidan – Axpo Power AG

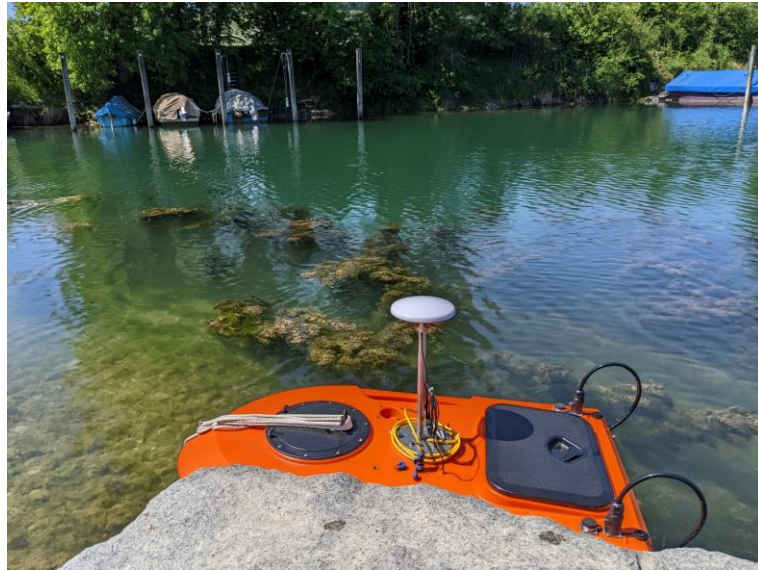
### Single Beam

The lakebed is surveyed using vertical echo-sounder pulses along a grid pattern, with gaps between survey lines interpolated. DGNSS positions the sensor with an accuracy of a few centimetres per point

DGNSS: Differential global navigation satellite systems

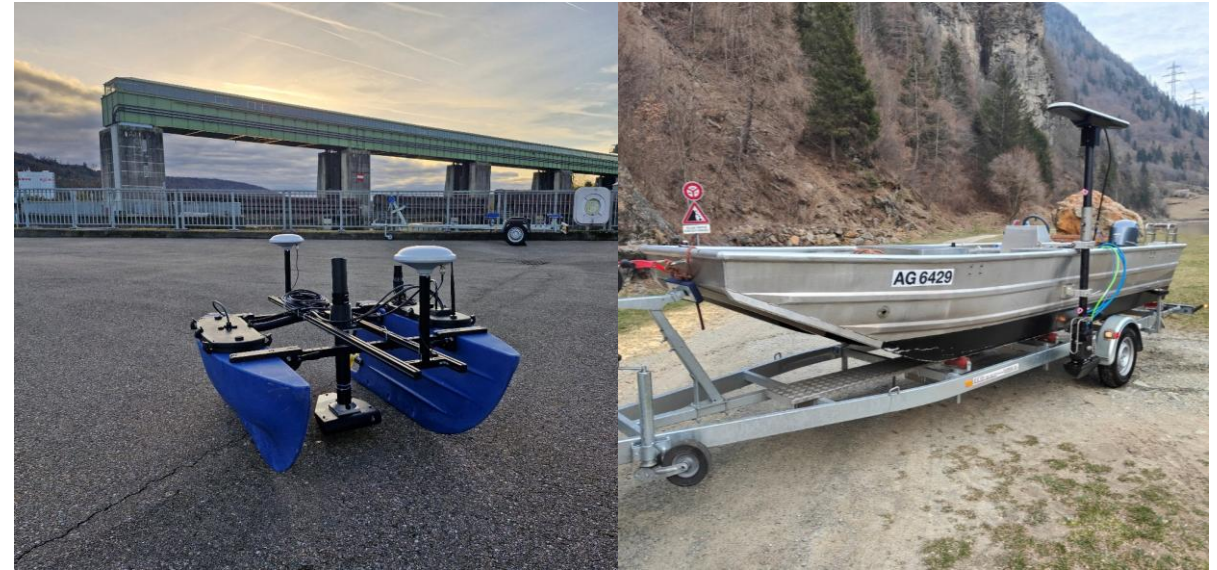
### Multibeam

A multibeam echo sounder also maps the lakebed using acoustic pulses, capturing data in overlapping swaths to avoid interpolation. An inertial measurement (IMU) provides the trajectory while the DGNSS provides positioning and stabilises the trajectory. Accuracy is likewise within a few centimetres.

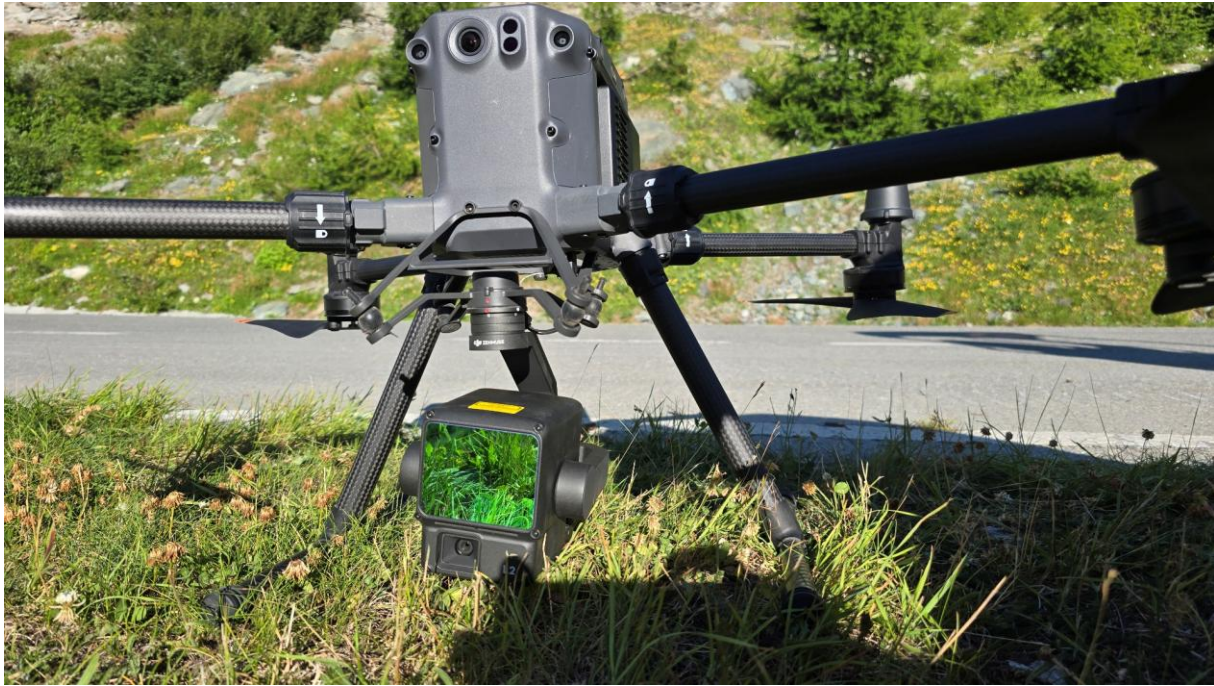
## Drones with LiDAR 3D scanning

| September 2024 | Echo sounding – single beam<br>LiDAR 3D scanning | First measurement after event |
| May 2025 | LiDAR 3D scanning | End of works |

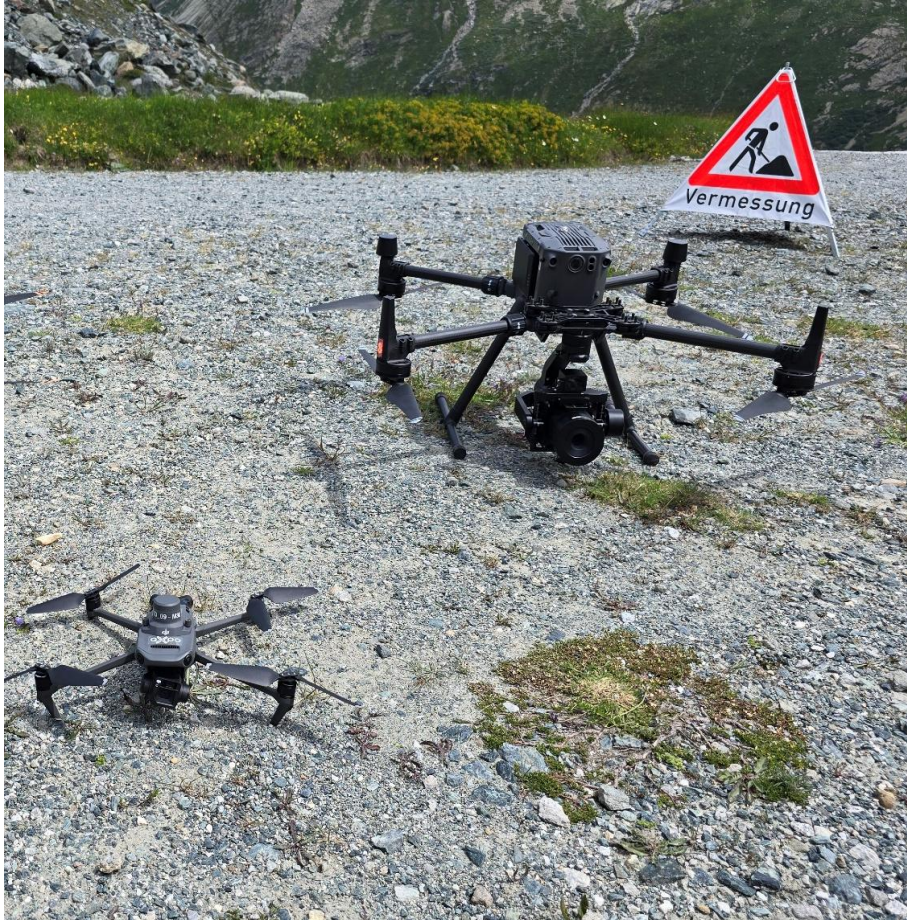
## Drones and photogrammetry

Blue flags: reference points; White points: camera positions

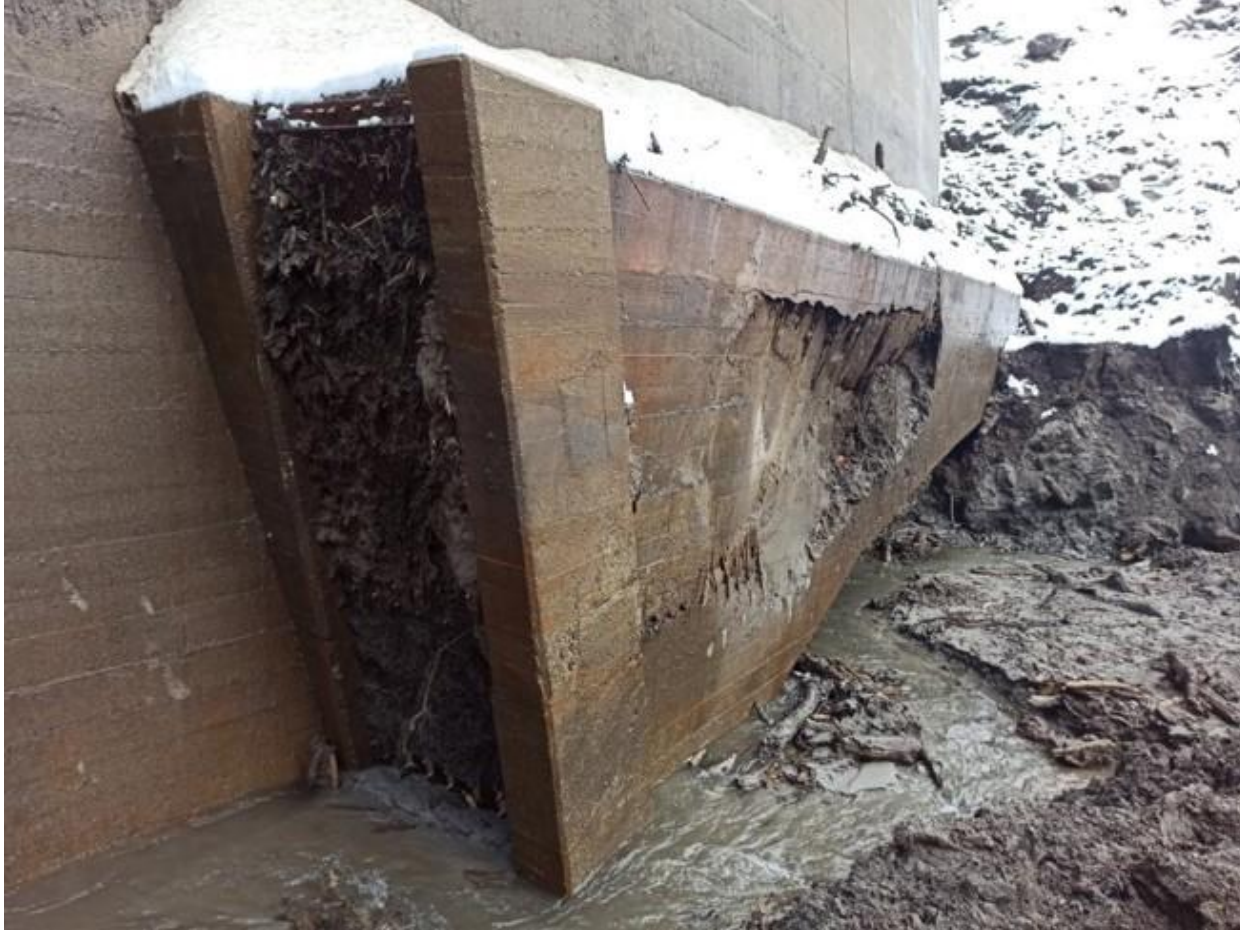
## Water intake

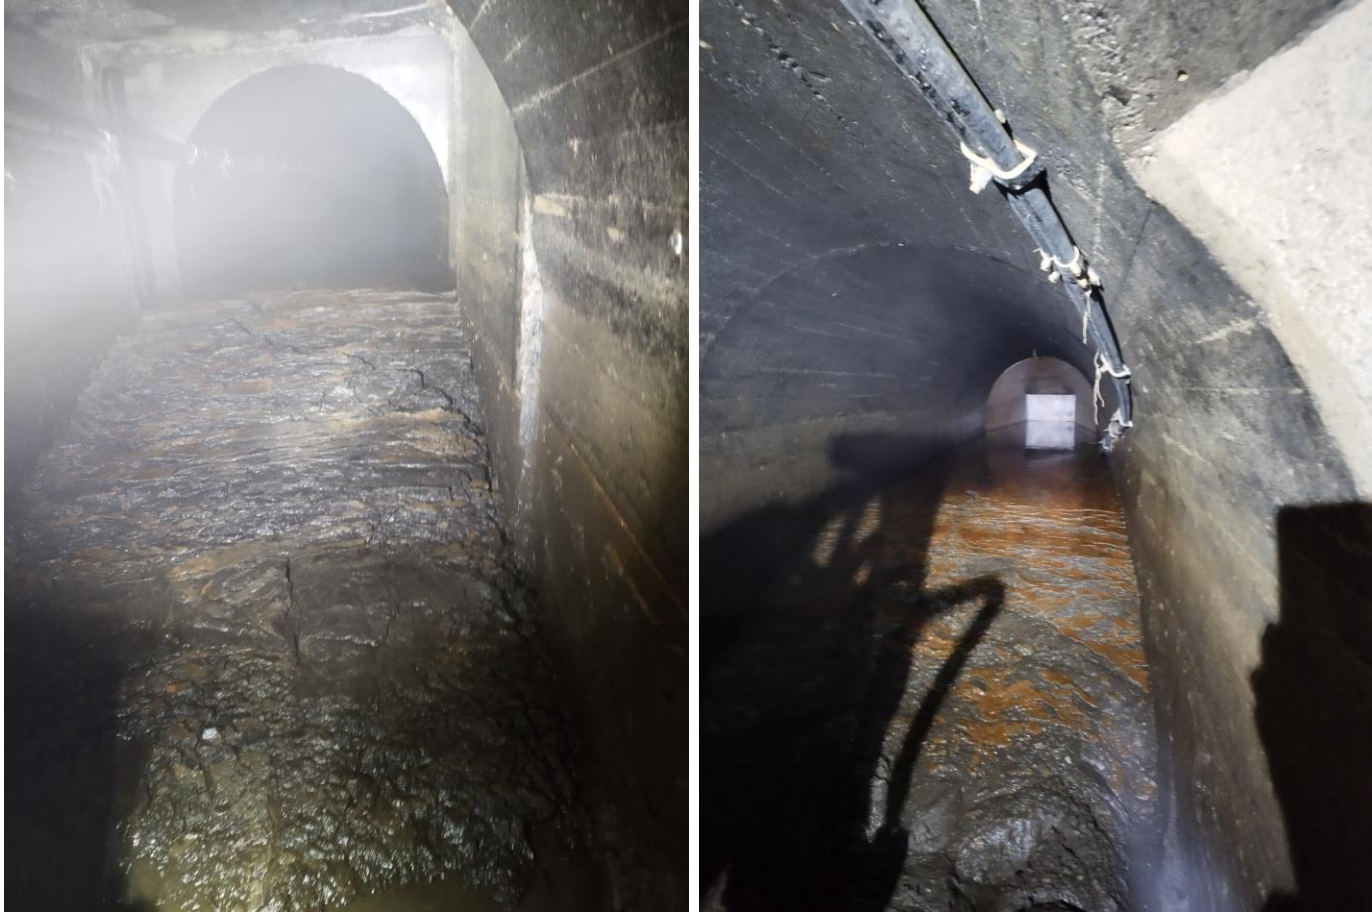
## Mud in the tunnel

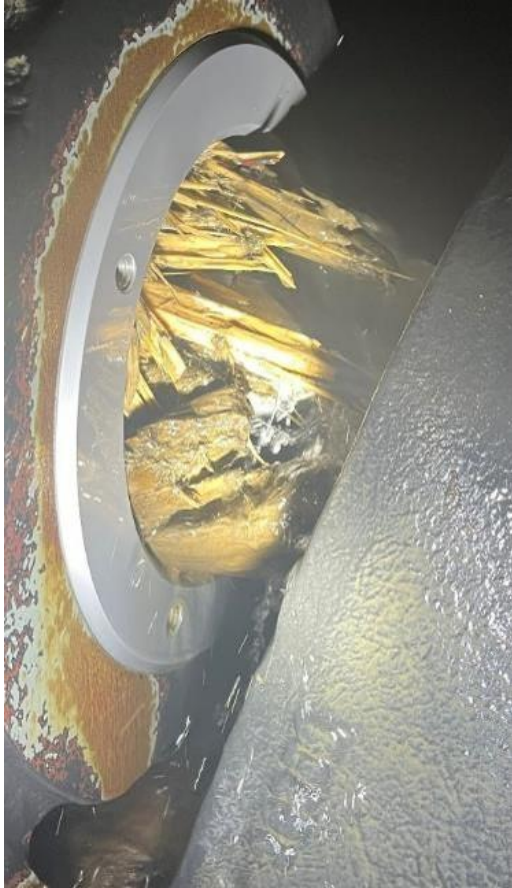
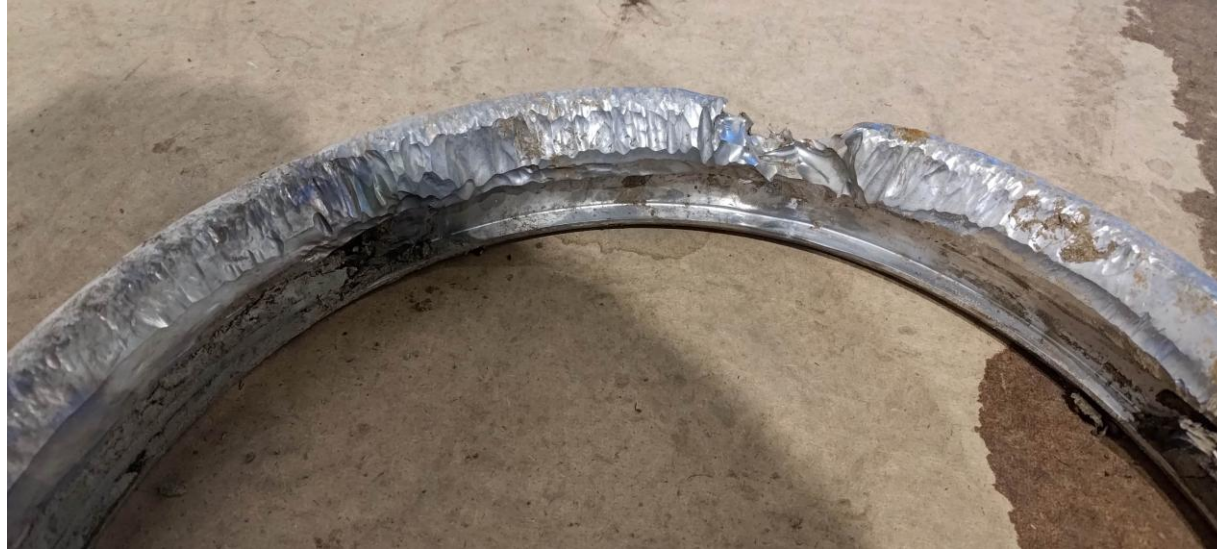
## Ball valve
